EPA REGION 10 DIVE REPORT

LOCATION: Marine Power & Equipment - Duwamish River site

PURPOSE OF DIVE: To determine the extent of any sandblasting debris that may be present on the river bottom near the MP&E site.

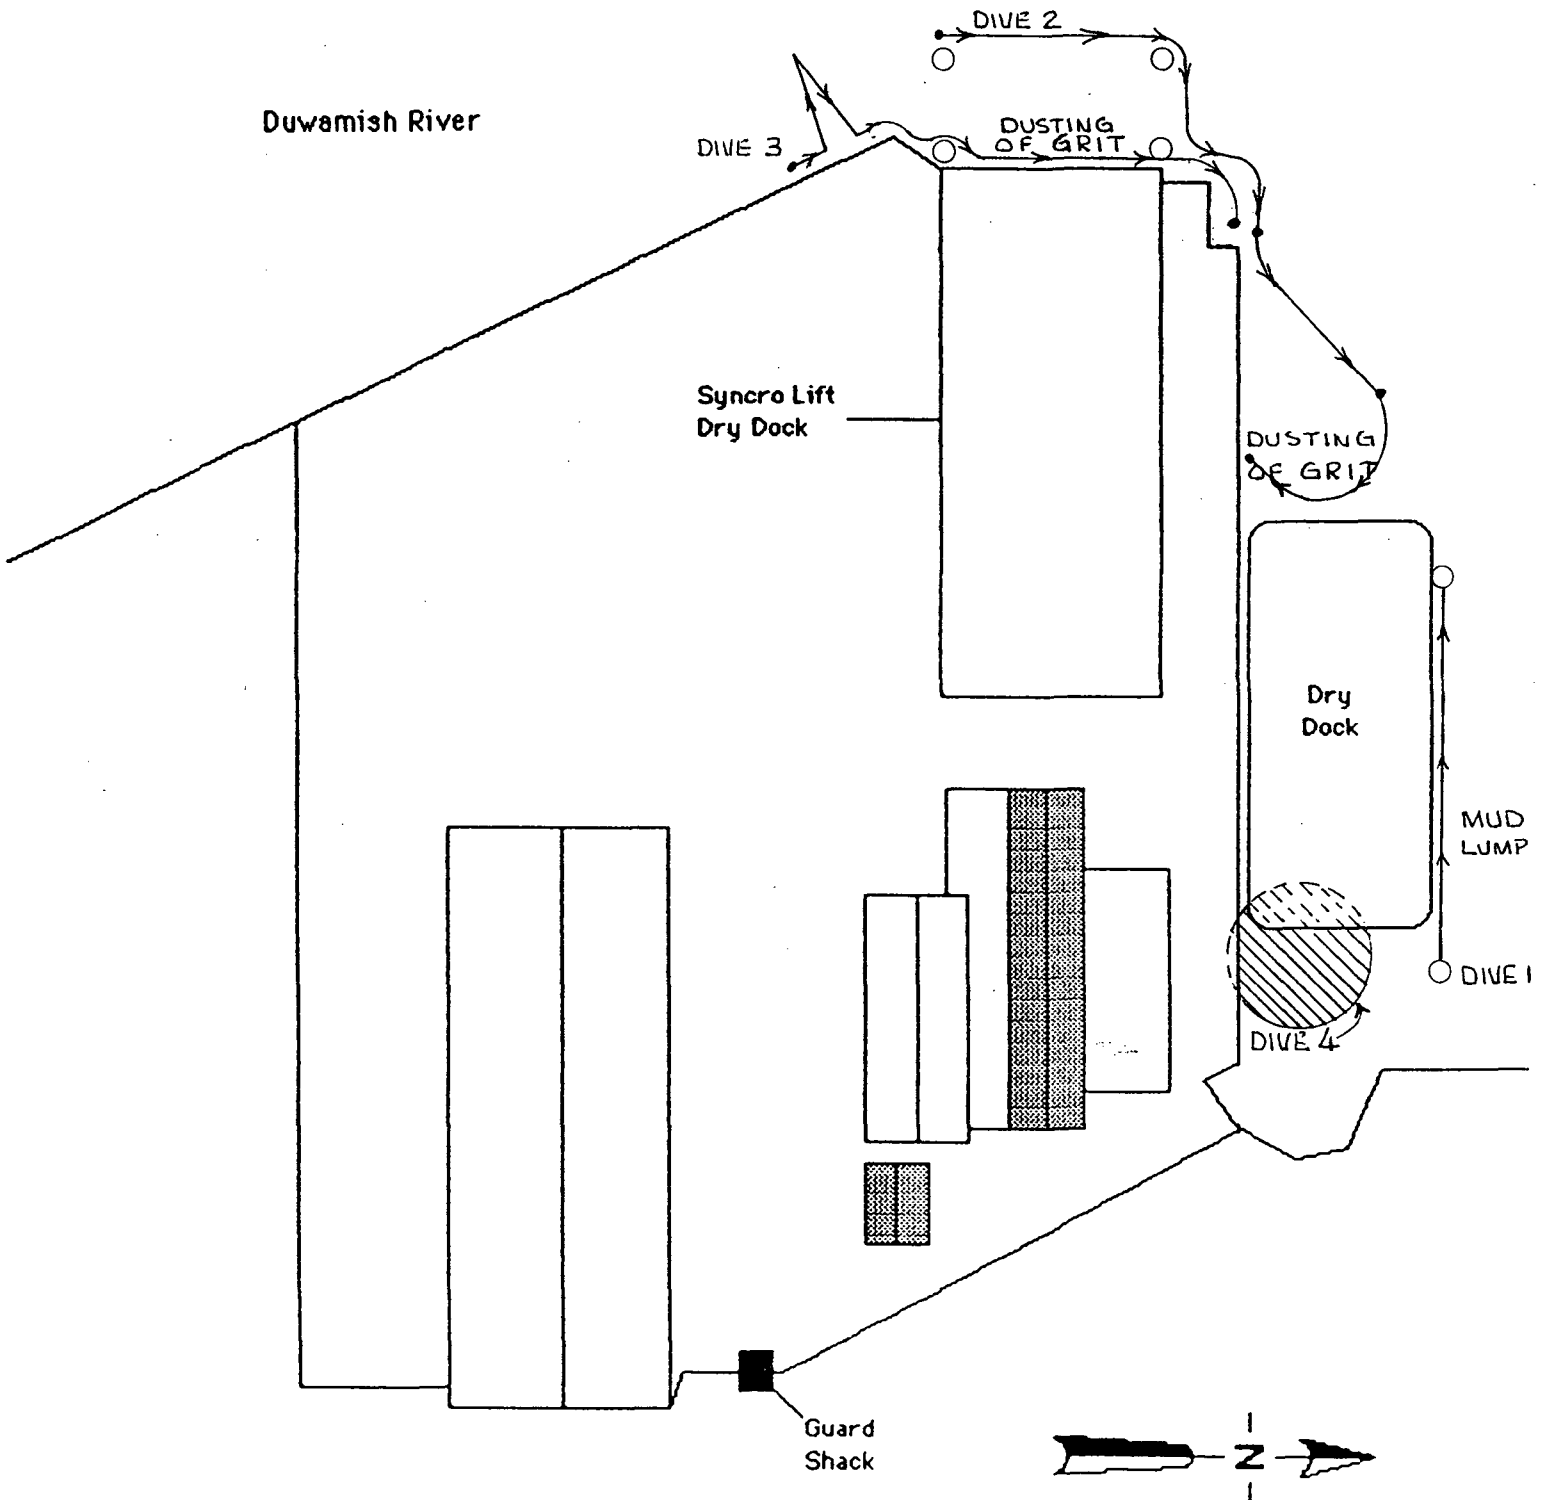
FIGURE 2

On the second dive, Matta and Albright entered the water at the upstream outboard dolphin off of the end of the table dock. (see fig. 2) The divers then followed the line as in the first dive proceeding downstream and then inward toward the pier and the dry dock. In this area, the bottom consisted of hard mud and there were no large piles of debris present. On this dive, divers noted a light dusting of sandblasting debris off of the river side of the drydock. Divers also investigated the corner of the the pier between the table dock and the dry dock and found no sandblasting debris there.

On dive 3 Duncan and Matta entered the water at the pier face upstream of the table dock and first followed the bottom out into the river for about 50 feet. The divers then returned to the base of the pier pilings and followed the pilings on the bottom to the end of the table dock. The divers then followed the edge of the table dock

in a direction downstream and followed the base of the pilings around the edge of the pier (fig. 2). At the beginning of the dive at the pier face, the divers noted small amounts of metal debris at the base of the pilings and in the adjacent areas toward the river channel. The bottom consisted of hard mud, and no sandblasting grit was apparent in the sediment. On the bottom along the edge of the table dock there was a dusting of sandblasting grit on the sediment surface which was about 1/2 inch thick. The bottom along the edge of the table dock was mounded and sloped downward toward the table dock. There were no apparent deposits of sandblasting grit noted on the bottom at the end of the pier between the table dock and the dry dock.
